## Capital Area Tech Session March 16

The Capital Area section attended a Tech Session hosted by Healey Surgeons in Takoma Park, Md on Saturday March 16. Run by Bruce and Inan Phillips, Healey Surgeons is well known to Healey enthusiasts in the Mid Atlantic. They supply a wide range of Healey parts and Bruce performs comprehensive service work on Healeys. The subject of the tech session was how to service the front wheel bearings on Big Healeys.

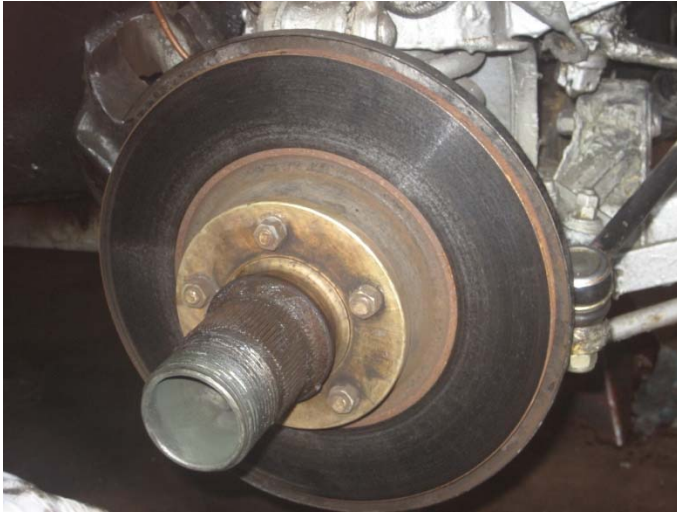
PICTURE 1 Ready for Hub Dissassembly

After safely placing the car on jack stands, remove the wheel. The first step would be to remove the brake caliper. Picture #1 shows the hub ready for disassembly. Note the caliper assembly is hanging behind the disc supported by a copper wire. To do this, remove the hydraulic hose clamp and the two nuts that secure the dust shield (present on BJ8s, not on earlier cars). An alternate approach is to disconnect the hydraulic line, but that would require bleeding the system after reassembly. It is probably easier to remove the caliper with the hydraulic line attached. Remove the clevis pins holding the caliper securing pins and withdraw the pins. Pull the pads half out, then use them as a lever to push the caliper pistons in. This makes the caliper removal easier. NOTE if you start with a full hydraulic reservoir, pushing in the pistons may cause the reservoir to overflow. Then remove the caliper securing bolts with a 5/8 wrench. Carefully remove the caliper and support it with a wire support, do not let it hang on the hose.

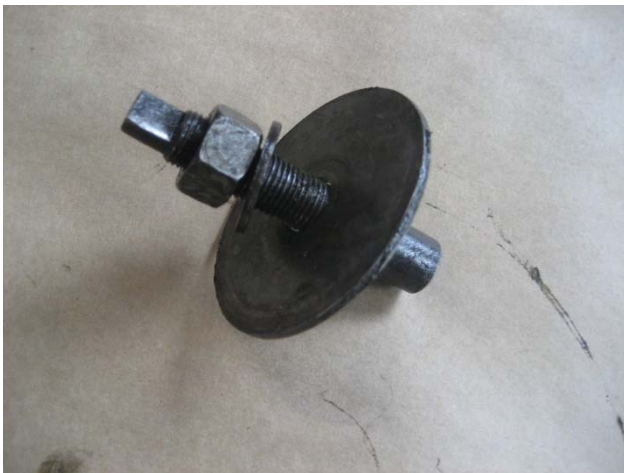
Picture 2 The authentic grease cup extractor tool

Now we are ready to remove the grease cup in the center of the hub. There is a special tool for this pictured in picture #2. However most of us do not have access to this, so a simple extractor tool can be made with a 5/16 bolt and nut, a 5/16 fine thread nut and a couple of fender washers. The fine thread nut needs to be welded on to the head of the bold and flats ground on the other end of the bolt. This homemade extractor is shown in picture 3. Attach the fine thread nut on to the stud on the grease cup and turn the nut on the extractor to pull the grease cup out of the hub. Hold the bolt using the flats on the extractor bolt end if required.

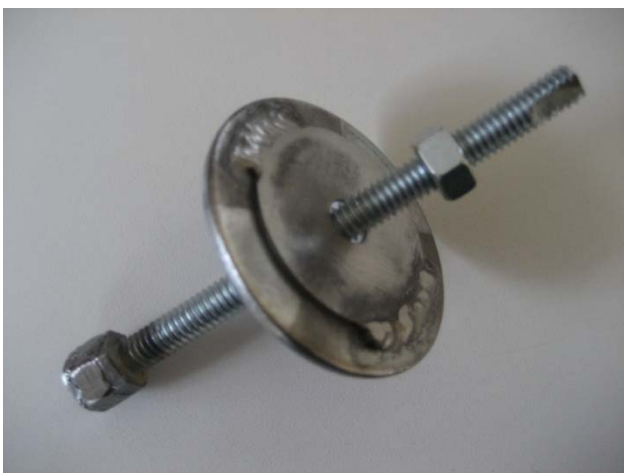
Picture 3 A homemade grease cup extractor tool

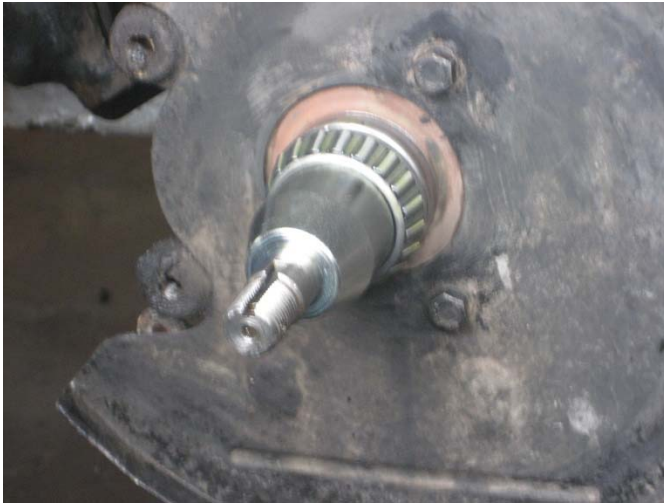
**Picture 4** The inner wheel bearing with the inner distance piece behind it and the cylindrical distance piece fitted on the stub axle.

pointed out that this configuration does two things. 1/. It strengthens the stub axle assembly by transferring the bending moment from just the root of the stub axle to a wider area being the contact patch of the inner distance piece. (see picture 4). Second it prevents the inner bearing races from spinning on the stub axle as they are held in place by the castle nut being tightened.

It is now time to reassemble the stub axle bearings. Put the inner distance piece on the axle first with the concave face away from the bearing. Fit the inner bearing with the smaller taper facing outward. Bruce's technique is to oil the bearings with SAE 80W/90 gear oil, get it shimmed up correctly and then disassemble everything, pack the bearings with grease and then reassemble. Accordingly, if following this process, oil the inner bearing. Then slide the cylindrical distance piece over the stub axle followed by the shims. If the bearings were not replaced and the bearings were rotating freely without end play, then using the existing shims may work fine. If, however new bearings were fitted then new shims will have to be selected. This process calls for a little trial and error. Bruce's suggestion was to start with a 30 thou, a 10 thou, a 5 thou and a 3 thou shim as the first shot. Make sure you record the thickness and sequence of each shim. Then fit the wheel hub on to the stub axle and then insert the oiled outer bearing with the taper facing inward. Fit the tab washer and make note of the witness marks on the tab washer so it faces the same direction as when it was previously installed.

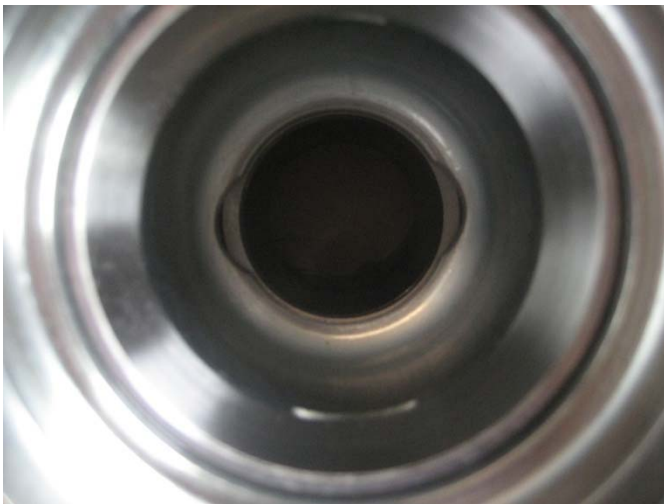
**Picture 5** Looking inside the hub showing where a drift can be used to drive out the old races (at 3 and 9 o'clock)

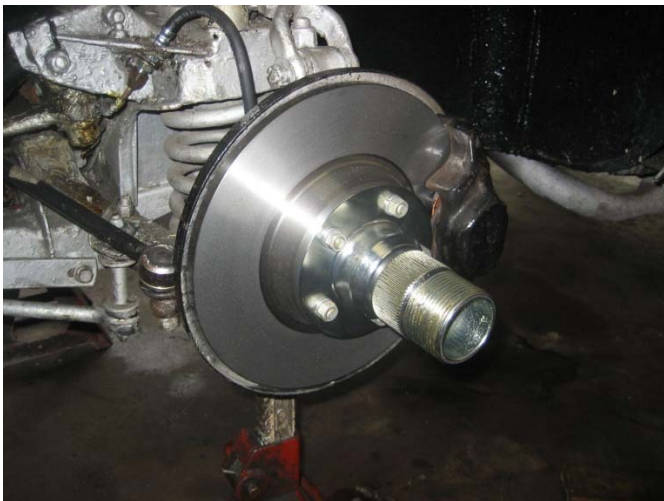
**Picture 6** The finished hub and disc assembly. (A new hub and disc was used in this install).

Reassemble the hub and add a little extra grease in the hub, but do not cram the entire cavity full of grease. Torque the castle nut between 40 to 70 Ft Lbs so that one of the slots in the castle nut is either vertical or horizontal to align with the holes in the stub axle. Insert the split pin through the hole on the hub assembly using split pin approximately 1.25 inches long. Bend the split pin tab to lock the castle nut in place and reinstall the grease cap. The completed entire assembly is shown in picture
